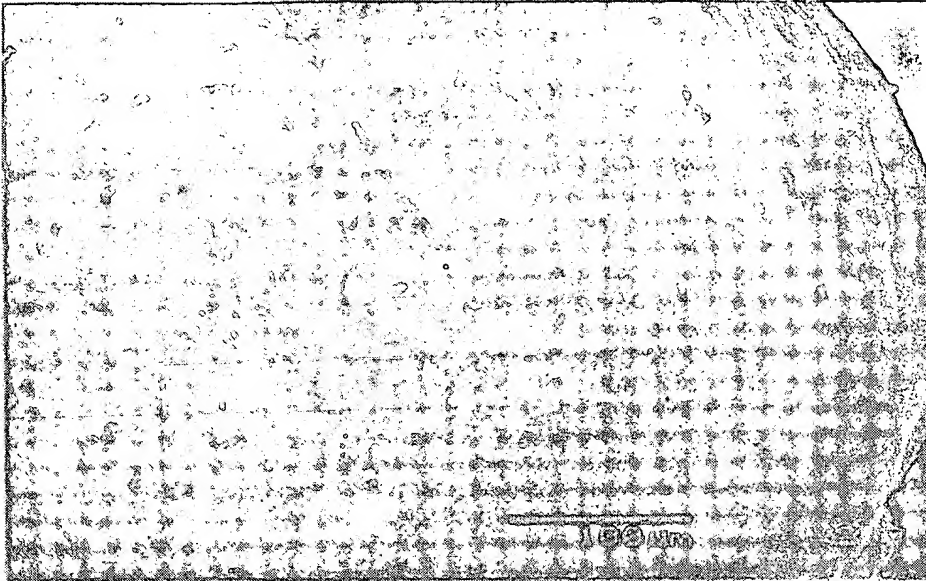
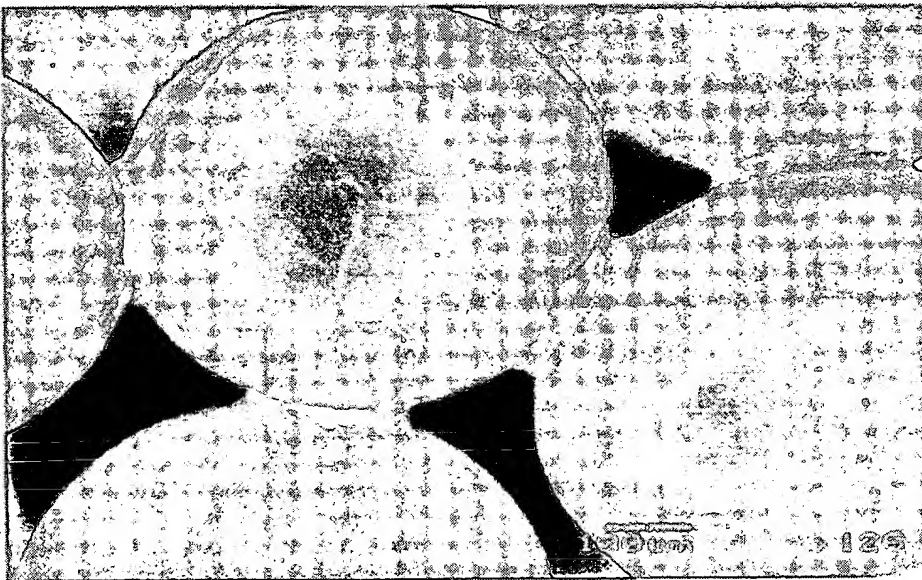
SEM micrographs of the Hayes CrCoMo sample after ASTM F746 corrosion test indicates intergranular corrosion attacks.

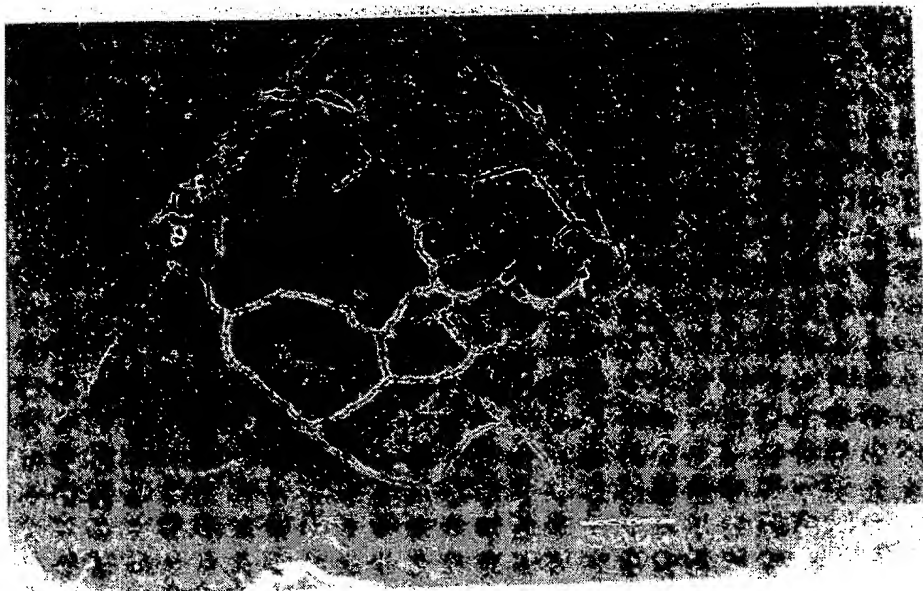
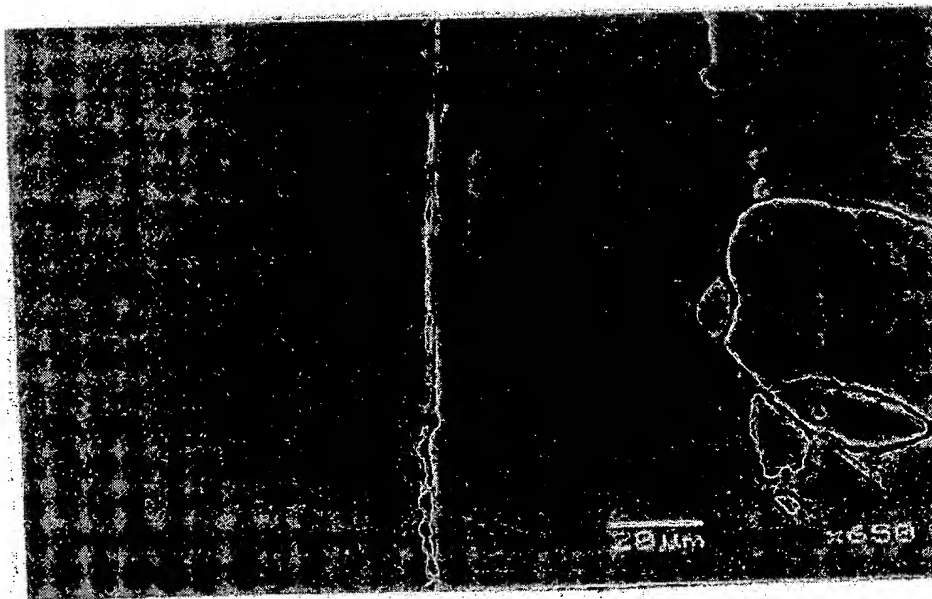
SEM micrographs of the Hayes CrCoMo sample after ASTM F746 corrosion test exhibiting corrosion attacks.

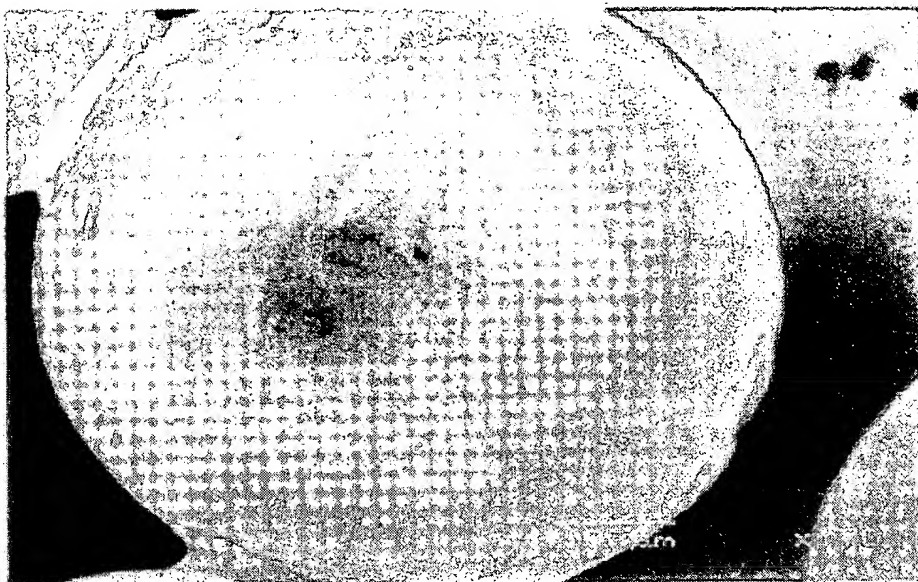
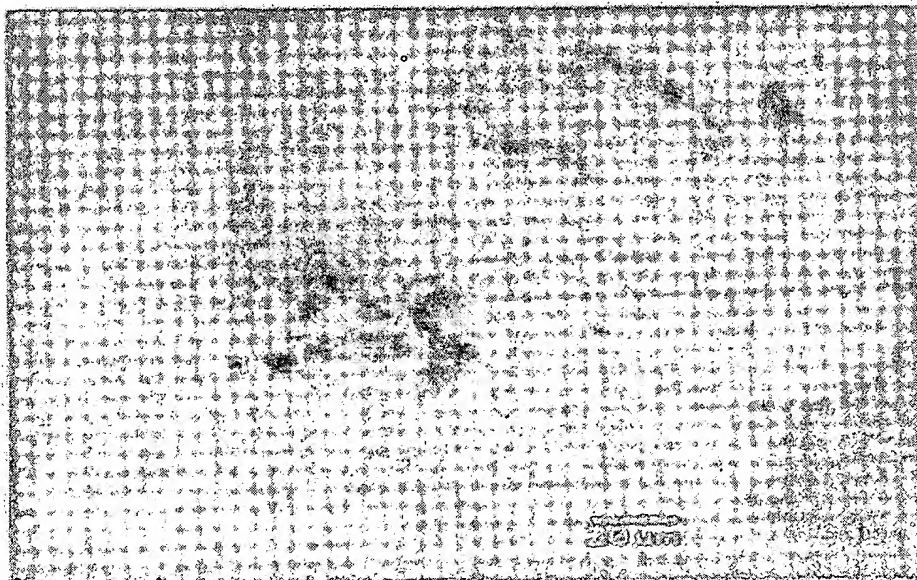
SEM micrographs of the Hayes CrCo sample prior to any corrosion test.
